DOVER LAKE DAM

GOOCHLAND COUNTY, VIRGINIA

VA. NO. 07503

# PHASE I INSPECTION REPORT

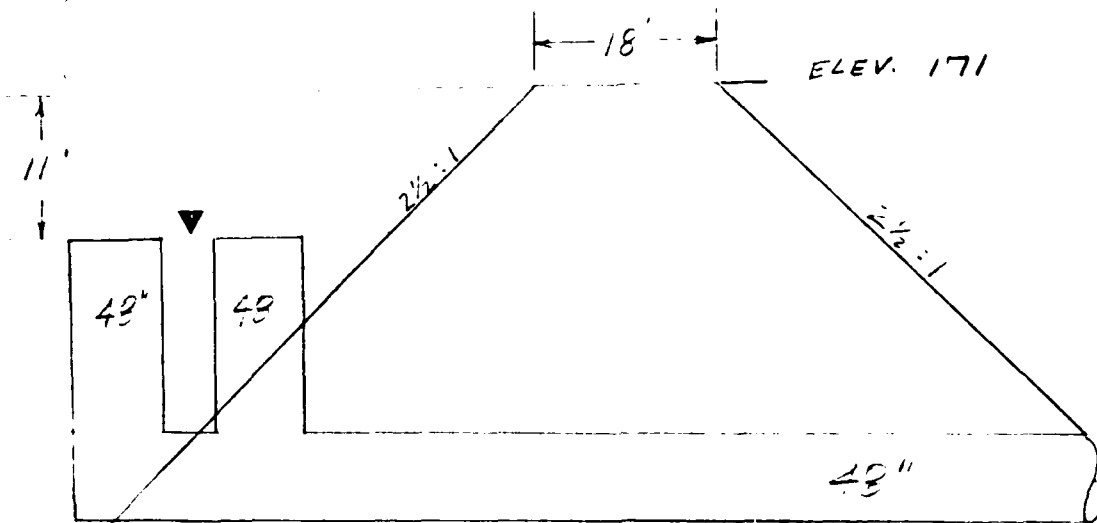
FIELD SKETCH  
PRINCIPAL SPILLWAY  
SHEET 2

One reinforced concrete anti-sweep collar was installed around the principal spillway pipe, upstream of the core trench in order to control any potential piping problems along the spillway pipe. Details of the principal spillway and riser are shown on Field Sketch No. 2 of Appendix III and Plate 3, Appendix I. No internal drainage system was provided for this structure.
